Blue Goose, -- the continuing saga – The House Leaks

Al and Pat Parker

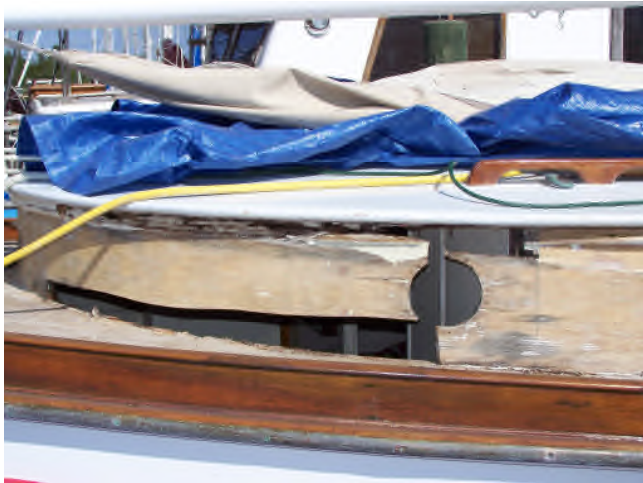
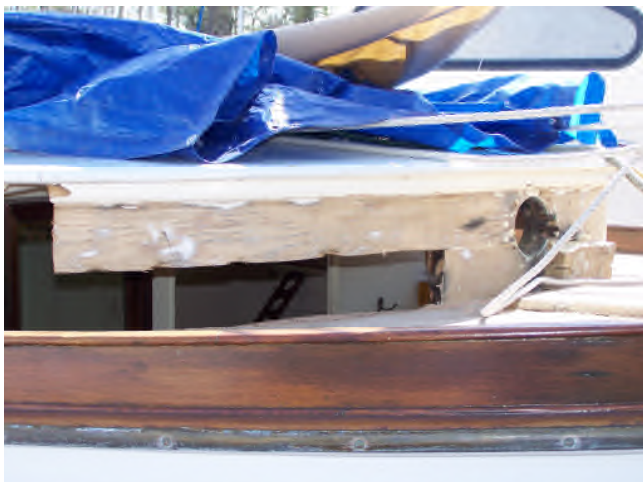
After closer inspection, Mike, the fellow who had done the great work below the water line, said, “I need to sand the paint off all the house (coach) sides to see just how bad things are.” He spent a Sat. morning doing so, and cutting away the rotten areas. When I saw it that afternoon I felt quite sick. Our poor old boat looked like Toothless Joe after a bad fight.

Mike said, “we’ll have to remove the whole house, make some forms for bending, and replace the sides, all around”. I had ordered some oak to use in repairs, and in my despair said, “no, we’ve been 7 months and many \$1k, can you just close it up as best you can for this year?” He reluctantly agreed. Then a day or three later I got an email in which he said he would not be able to continue the job, with no explanation. I asked him to return the wood of mine that he had, and he did. I went on another search for a qualified wooden boat carpenter, and found Jeff, who lived about a 90 minute drive away.

Jeff was eager to work on Blue Goose, he had known the boat from a few years ago, but hadn’t worked on her before. He had other work going on, but said he could work on the weekends. He also felt the whole sides should be replaced, and that he could do it, with my help, by supporting the roof, and cutting away everything else holding it up. This time I agreed.

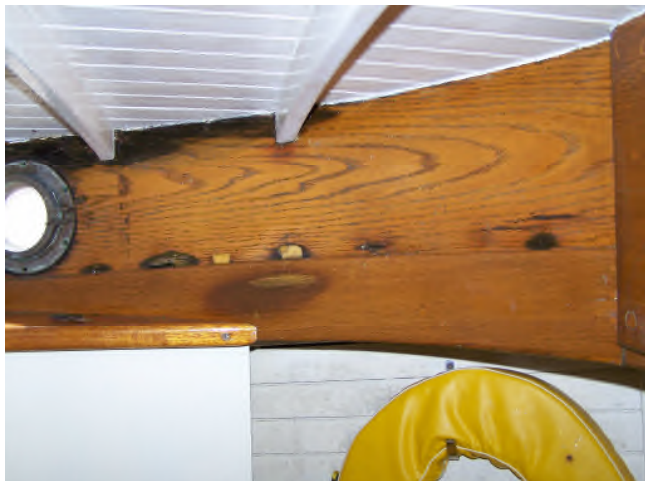
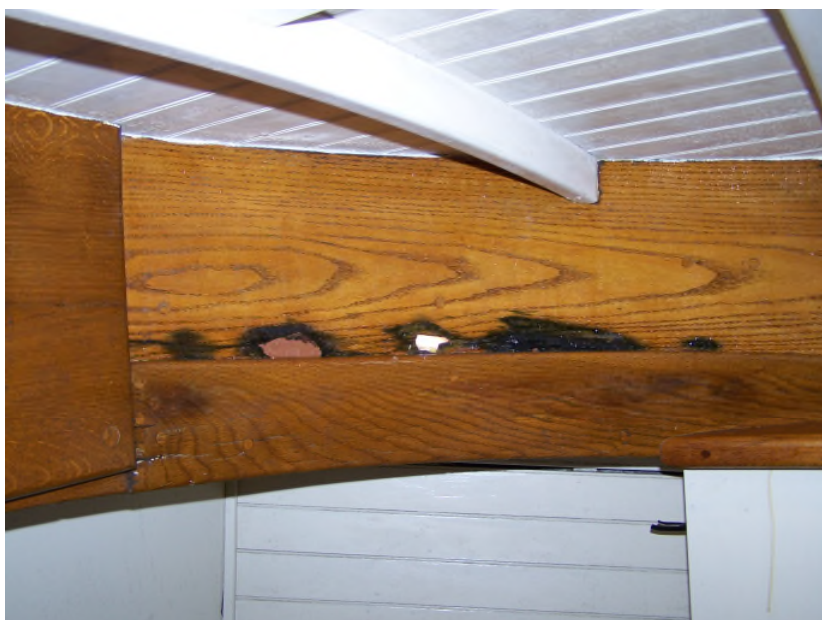
No two pix can show how bad it was, but here are two more of the inside of the cabin. You can see the black water/rot markings of the oak, as well as some old patch attempts.

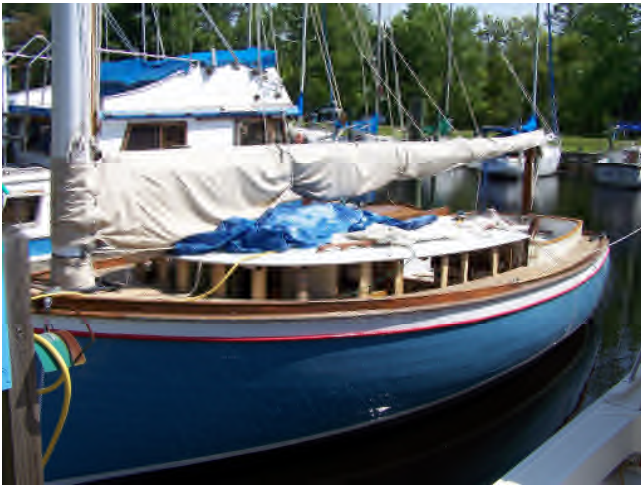
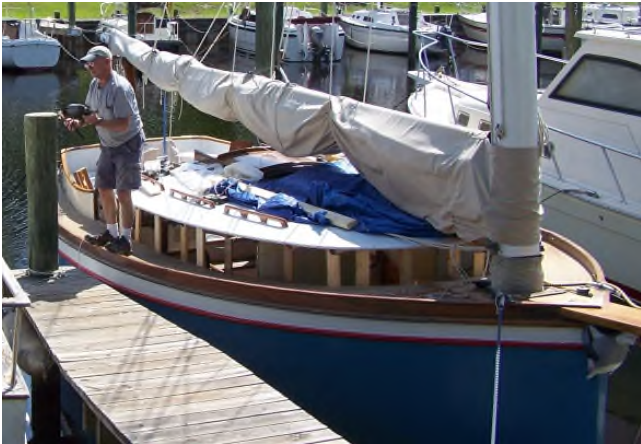
The house sides were originally 1 inch thick oak, apparently steam bent around the forward curve. Jeff would use 4 layers of ¼ inch marine plywood, which could be bent cold, and laminated in place with epoxy, for the curved area, and 2 layers of ½ inch plywood for the straighter aft sections.

This work started the last weekend of April, and continued for 4 weeks. Jeff cut and fitted all the layers, and once he was prepared, we both worked quickly to prime, apply epoxy, and temporarily screw the laminations in place. This took several sessions to complete.

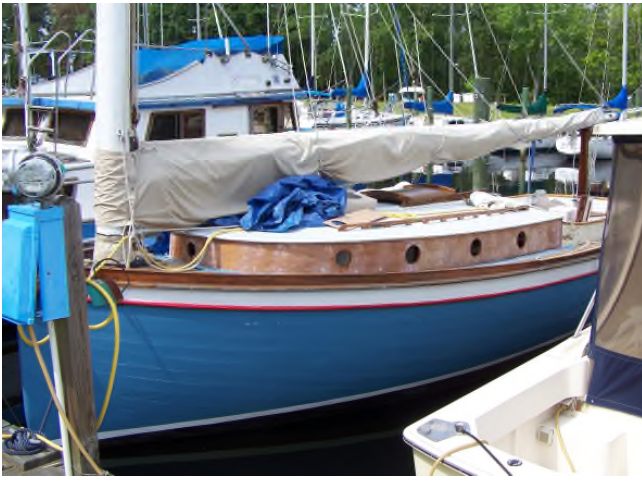
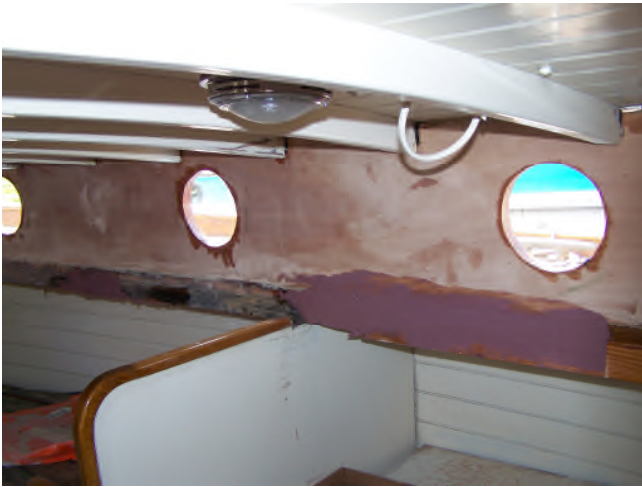
Again, 4 laminations $\frac{1}{4}$ inch thick forward, and two, $\frac{1}{2}$ inch thick aft. Once in place, all temporary screws were removed, holes filled, the sides sanded smooth, and port light holes cut in place. Primer and 2 coats of off-white paint applied, port lights installed, and only the interior remained to be finished off.

As of this writing, late Sept. 2015, I have not completed the finish work. I have 3/32 inch thick oak to use as veneer all the way around the inside, with a trim piece below it, hopefully to look much like it had before, as seen above. The interior must be sanded smooth, the veneer pieces cut to fit and applied. I was interrupted by the next major challenge of the continuing saga of the Blue Goose, which descended upon us a week after this point, as we went for our first sail in almost a year, on Memorial Day weekend, 2015. As they say, “stayed tuned for coming events!”
